Review of the geomorphological effects of the 1991 Limón earthquake

Adolfo Quesada-Román

Universidad de Costa Rica (UCR), Escuela de Geografía (EG), San José, Costa Rica
adolfo.quesadaroman@ucr.ac.cr

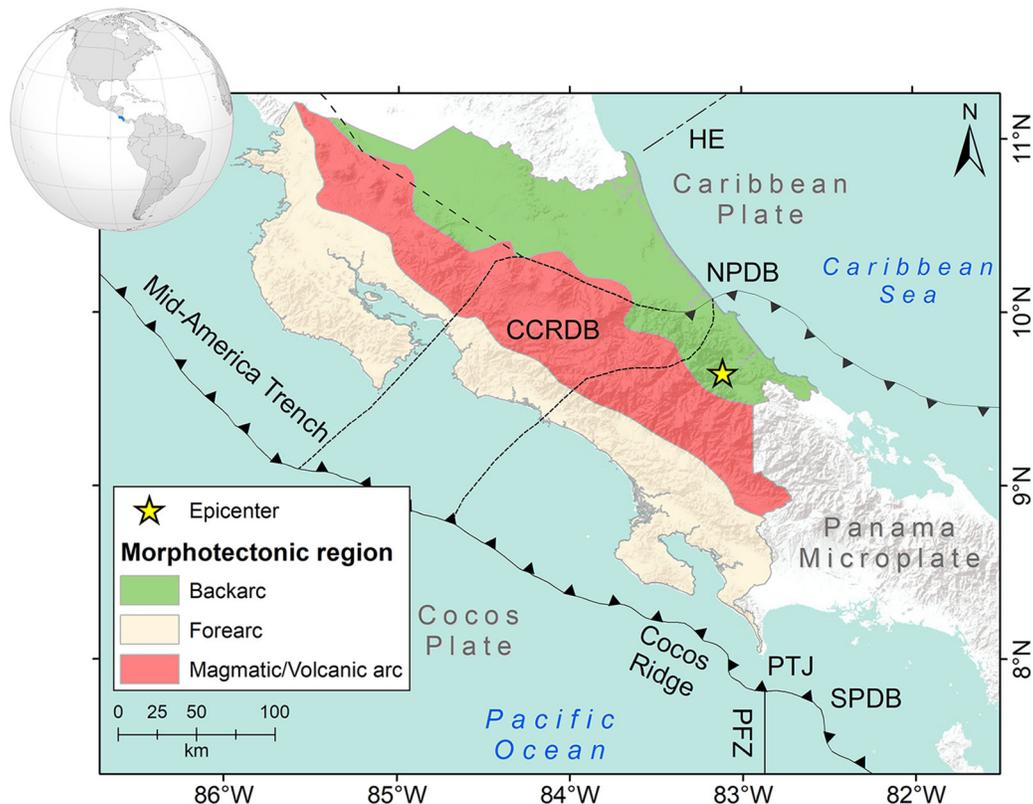
Fig. 1: Morphotectonic framework of Costa Rica (Source: ArcGIS Online Basemap; Projection GCS; Datum WGS84). HE: Hess Escarpment; CCRDB: Central Costa Rica Deformed Belt; NPDB: North Panama Deformed Belt; SPDB: South Panama Depression Belt; PFZ: Panama Fracture Zone; PTJ: Point Triple Junction; Epicenter of 1991 Limón earthquake (DeMets et al., 2010; Morell, 2016; Arroyo-Solórzano et al., 2020).

The effects of the Limón earthquake were directly related to the structure of the backarc (Marshall, 2007; Fig. 1), which represents the Caribbean lowlands of Costa Rica and has a SE continuity towards Panama. The Limón Basin, which is in the backarc, suffered the greatest direct and indirect effects from the Limón earthquake. The northern limit of the Limón Norte Basin is defined by a series of positive buried structures, aligned in an EW direction and of Middle Late Eocene age. The regional uplift of the southern coastal region of the Caribbean reveals that the structural-tectonic styles are different (Fernández et al., 1994). The area between Limón Norte and the Limón Sur basins is an extension of the Central Costa Rica Deformed Belt and remains tectonically active (Fernández et al., 1994; Marshall et al., 2000).

The Limón earthquake had its epicenter in the Limón - Pandora area at the geographical coordinates 9.685° N and -83.073° W (Fig. 1). The primary rupture had four sub-events in a 25-second period and a rupture area of 3200 to 4500 km². The size of the rupture zone, the complexity of the main event, and the number of aftershocks indicate that secondary faults structures could be associated with the main rupture plane (Montero et al., 1991; Güendel et al., 1991; Rojas, 1991; Goes & Schwartz, 1991). Geodetic and seismologic data indicate that the main rupture dips landward at an angle of about 30° and is approximately 40 km wide and 80 km long. Dislocation models suggest 2.2 m of slip on a causative thrust fault that strikes between 105° and 120° (Plafker & Ward, 1992). The interpretation of the focal mechanism, the rising of the coastline and the horizontal movement towards the NE in the surroundings of Limón suggest that the main fault plane projects into the sea (Denyer et al., 1994a).

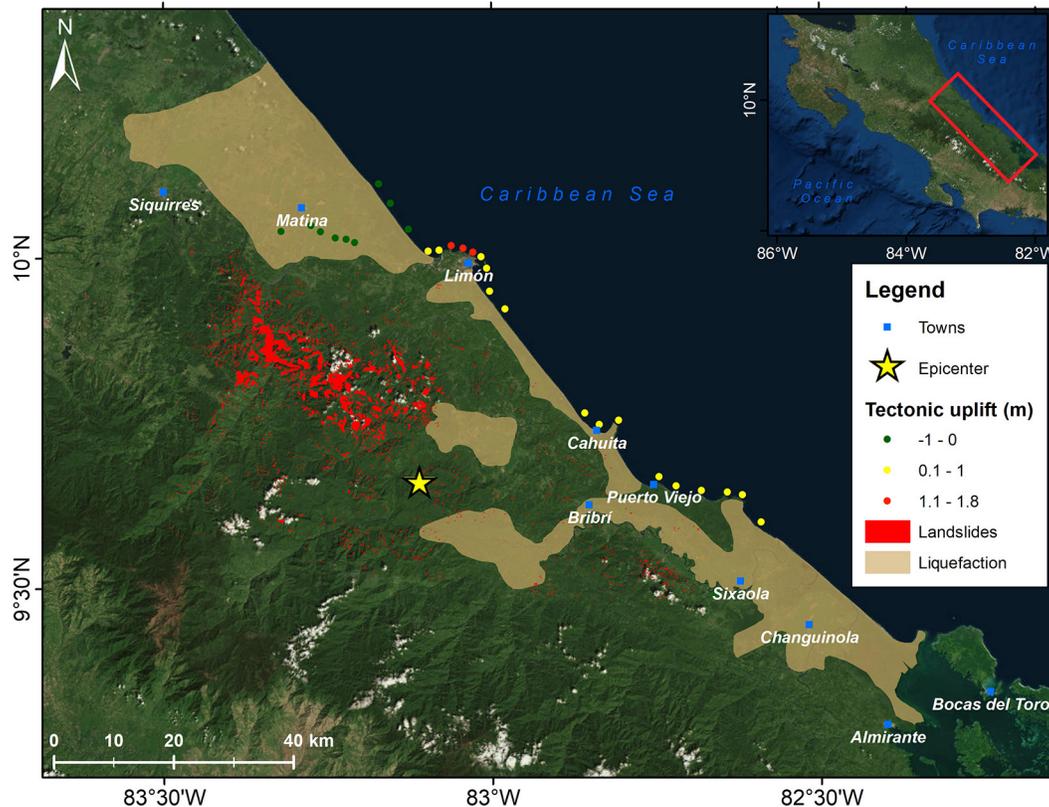
Fig. 2: Geomorphological effects of the 1991 Limón earthquake. Modified from Camacho & Viquez (1994), Denyer et al. (1994a, b), Hernández et al. (1992), Mora & Mora (1994) and Mora & Yasuda (1994).

The 1991 Limón earthquake is an interesting example to illustrate and help understand the geomorphic dynamics and evolution in tropical conditions. The most significant processes resulting from the event were the coastline uplift, liquefaction, landslides, subsequent floods as well as the extraordinary sediments load in the rivers and coasts, a tsunami, and in recent years the coastal erosion processes (Fig. 2).

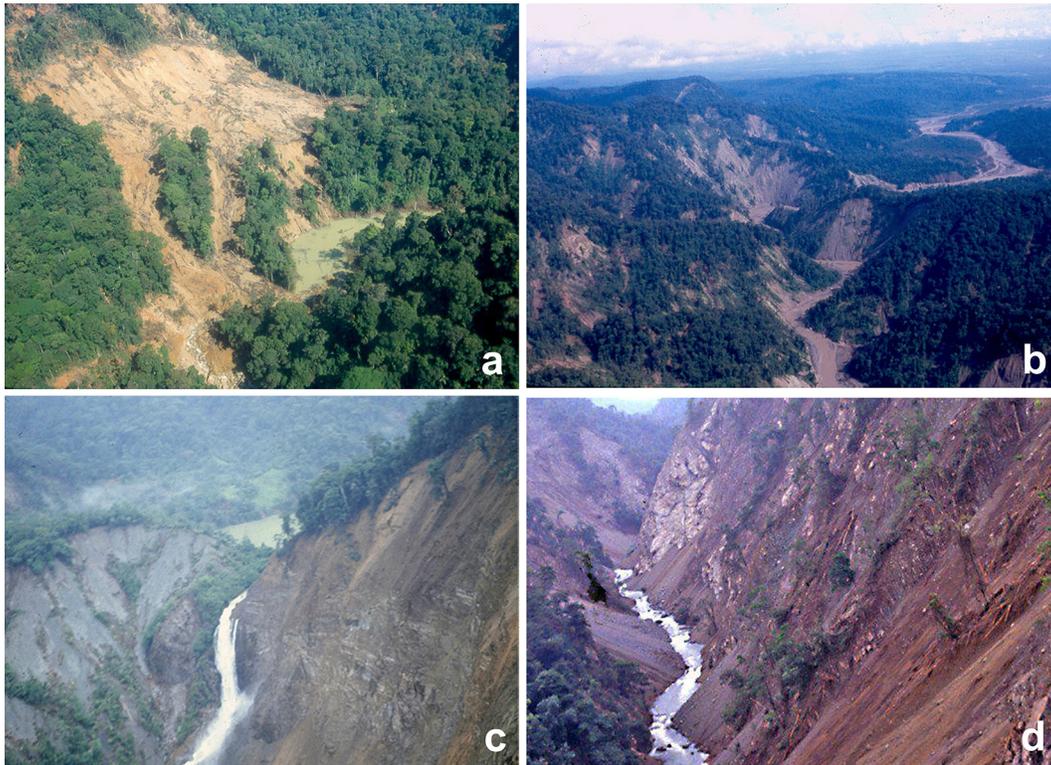
Fig. 3: Coseismic landslides in the upper basins of Banano river (a) Chirripó river (b,d), and Ayil lagoon in Chirripó basin (c). Photos provided by Sergio Mora Castro.

Landslides impacted approximately 2000 km². The most affected areas were the upper basins of the Estrella, Banano, Bananito and Chirripó rivers (Fig. 3), where massive and extensive landslides occurred (Mora & Mora, 1994). The landslides map by Hernández et al. (1992) also coincides with the broad cartographic analysis by Mora & Mora (1994) and the one focused in Panama by Camacho & Viquez (1994). Hernández et al. (1992) determined a total of 1834 landslides caused by the earthquake, which varied in size depending on their location (lithology, slopes, degree of weathering, and rainfall). The otherwise forested areas of the Talamanca Cordillera exposed by each of the coseismic landslides varied between 3157 m² and 19.15 km².

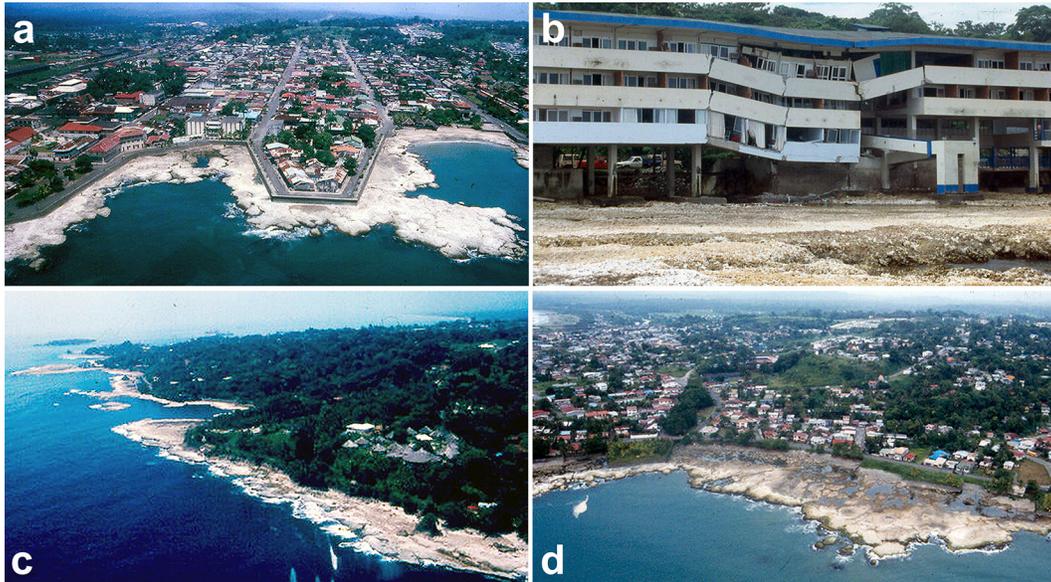
Fig. 4: Coastal uplift in the city of Limón and surroundings (a,c,d); collapse of Las Olas Hotel in Limón City (b). Photos provided by Sergio Mora Castro.

One of the most spectacular tectonic effects was the coseismic uplift of approximately 100 km of the Caribbean coastline. The magnitude ranged between 0.3 and 1.85 m in blocks separated by NE trending faults along the calcareous platform. There is also an inland manifestation, with an uplift greater than 3 m (Denyer et al., 1994a, Denyer et al., 1994b). This deformation was discontinuous and ranged from 40-50 cm near La Estrella river, 40 cm at Muelle Alemán, and 2 m at Playa Bonita. The terraces of the new coastline had different elevations, from 15 to 20 m in front of the Limón airport, 30 m to the left margin of the Banano river and about 50 m at the mouth of the La Estrella River. The new tide level on rocky beaches changed dramatically with varying results in different locations, including changes that reached more than 60 m at Playa Bonita (Amador et al., 1994).

Obaldia et al. (1991) indicate that changes in the coastline were greater in magnitude in Limón and decreased towards the northwest and southeast of the city. A maximum uplift of 1.51 m was found between the Moín pier and Portete beach, and a minimum of 0.36 m was located west of the Limón cemetery. The changes in slope as a result of the coseismic uplift are not uniform (Fig. 2). However, these variations directly affected the drainage regime and infrastructure works for which the level modifications are important. To the northwest of Limón, in the Moín-Doce Millas town, the change in elevation decreases uniformly. In contrast, to the southeast of Limón, the coseismic deformation was positive and decreased in magnitude away from Limón (Denyer et al., 1994a; Fig. 4).

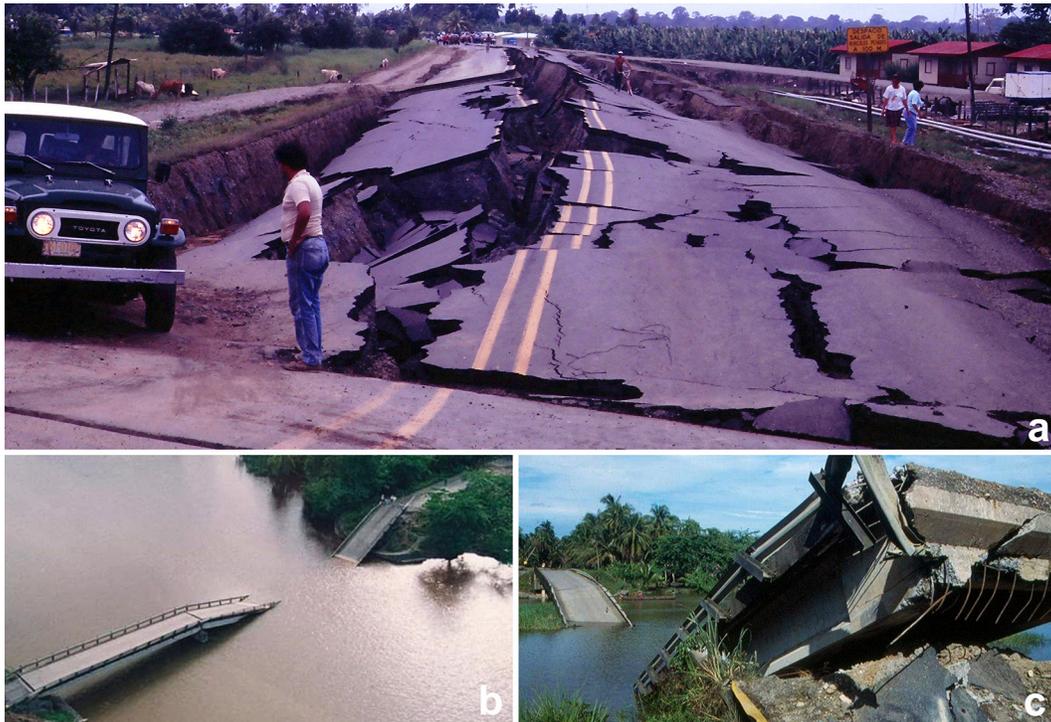
Fig. 5: Roads and bridges collapsed due to fracturing, lateral displacement and liquefaction. A destroyed road section close to Limón (a), and La Estrella river bridge (b,c). Photos provided by Sergio Mora Castro.

Approximately 3000 km² were affected by soil liquefaction. This event occurred in the lowlands of the eastern sector of the Costa Rican and NW Panamanian Caribbean coast, with special activity in the littoral corridors, sandy bars, and borders of estuaries, channels and coastal lagoons. Deformation on these landforms, including soil fracturing (Mora & Yasuda, 1994) developed more intensely due to the unconsolidated materials. The liquefaction processes caused the collapse of five bridges, most of them small in size but severely damaged and eight railway bridges settled or suffered partial deterioration (Fig. 5). A total of 80 km of pavement and road fill were destroyed, preventing vehicular traffic (Sauter, 1994).
